# Preservation Tech Notes

## WINDOWS NUMBER 22

### Maintenance and Repair of Historic Aluminum Windows

**Kaaren R. Staveteig**  
Technical Preservation Services  
National Park Service

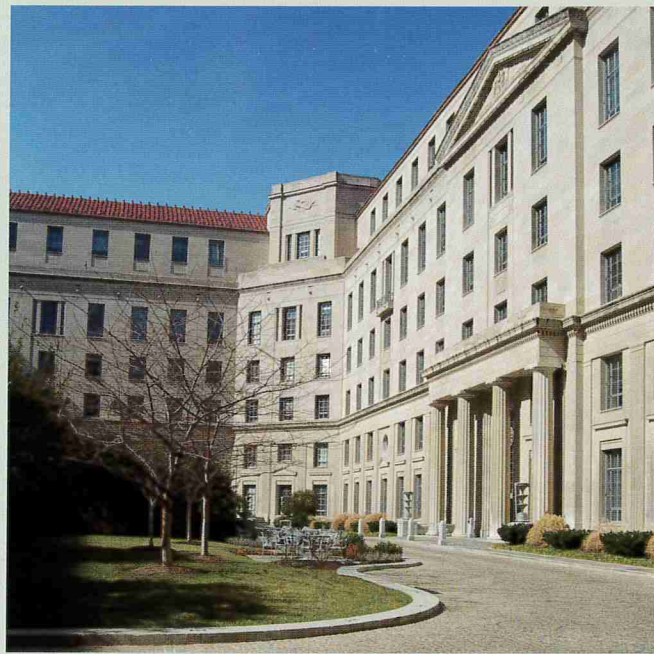
*Figure a. In the primary courtyard within the U.S. Department of Justice Building, the aluminum windows emulate the appearance of steel windows with true divided lights. Depending on the floor level and location, the windows differ in size and consist of a varying combination of fixed lights, casements, and a hopper-style unit.*

A window survey was first undertaken to record the condition of each window and to inventory the hardware, fasteners, and missing frame pieces. Although the windows retained a high degree of historic integrity, some changes had been made over the years. To allow for the installation of ventilation louvers or window-mounted air conditioning units, over 400 of the hoppers below the casements had either been removed or had been rendered inoperable and the wide vertical muntin removed. Although the historic windows were not designed for weatherstripping, some of the windows had been retrofitted with weatherstripping to reduce air infiltration as a result of worn hardware or deflections in the operable units. At various times, caulk had been applied to set in replacement glass or to fill in unwanted gaps. Areas of surface deterioration were also evident including discoloration and varying degrees of corrosion and pitting.

The renovation plan called for cleaning the aluminum window parts, replacing the existing glass and any missing or damaged parts, and making the historic windows fully operable again. Mock-ups of all phases of the work were required early on to establish the work standard to which the finished job would be held. It was anticipated that most of the work could be done in place, with work on the interior and exterior portions of each window done simultaneously.

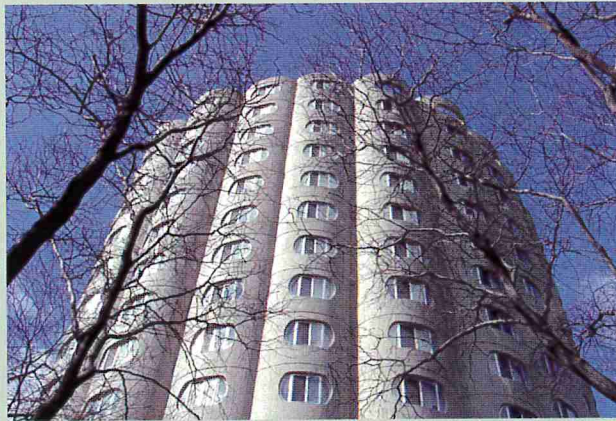
Figure a. One of two identical 16-story senior citizen apartment buildings within the Raymond M. Hilliard Center; each with 182 apartment units. The window openings are elliptical in shape and center on each reeded bay. (Photo: Holsten Real Estate Development Corp.)

The decision was made to save the historic windows for the first four floors of the towers, since they would be most visible from the ground. Units on the first four floors in bad condition were to be replaced by windows in better condition relocated from above floors. Matching aluminum replacement windows were to be installed on the upper floors.

The window survey provided an overall view of the necessary repair work to the historic units. There were standard components within each of the different window types and the aluminum had proved durable where not abused. Thus it would not be necessary to replace large numbers of the entire window assembly within each bay on the lower floors. The windows could be repaired, utilizing parts easily salvaged from other units within a building to replace worn-out or missing ones. In the total project, 336 original windows were to be repaired and 2,016 to be replaced.

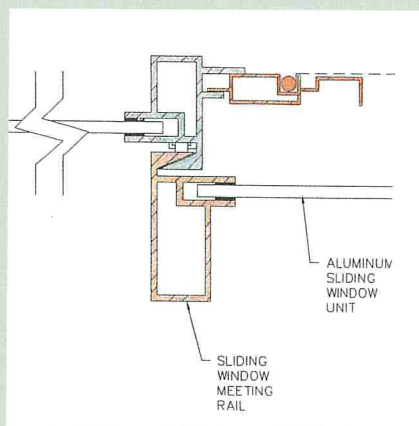
Figure c. Detail showing the sliding aluminum meeting rails in a closed position. (Drawing: Holsten Real Estate Development Corp.)

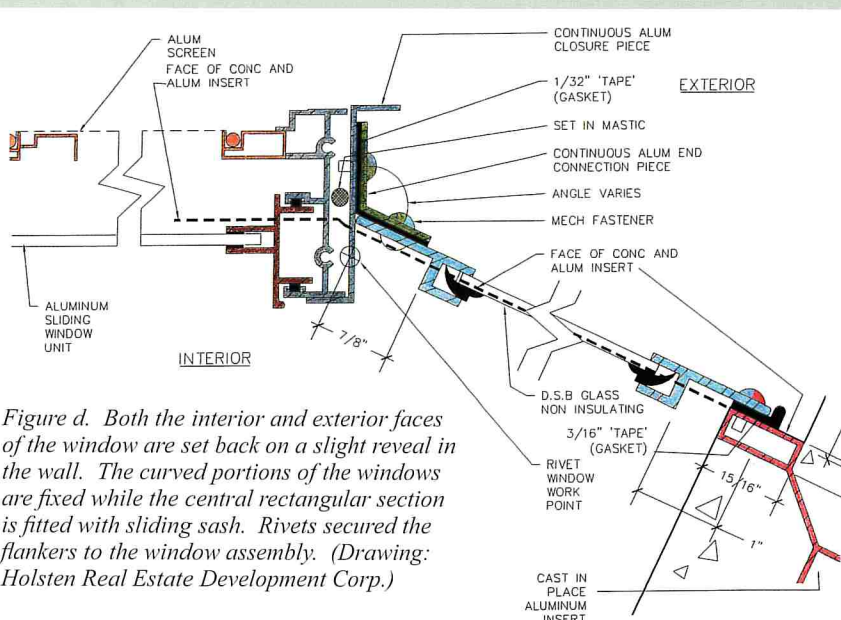
Figure d. Both the interior and exterior faces of the window are set back on a slight reveal in the wall. The curved portions of the windows are fixed while the central rectangular section is fitted with sliding sash. Rivets secured the flankers to the window assembly. (Drawing: Holsten Real Estate Development Corp.)

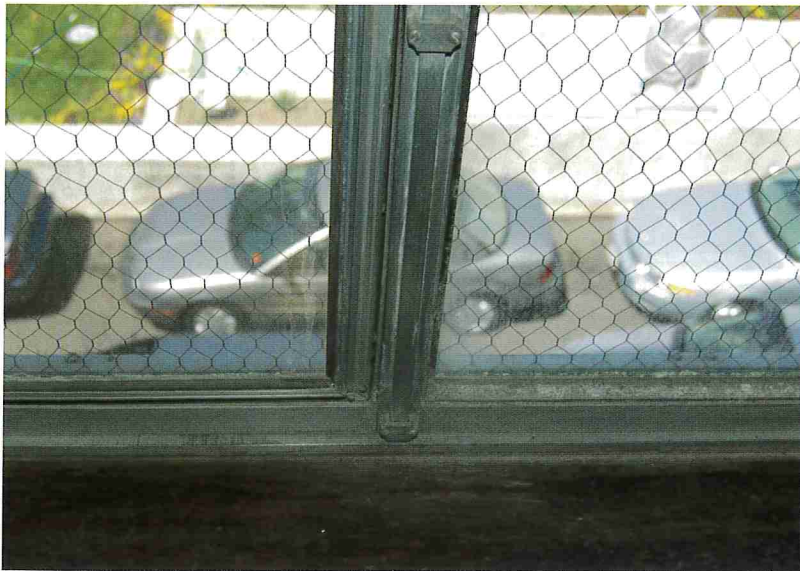
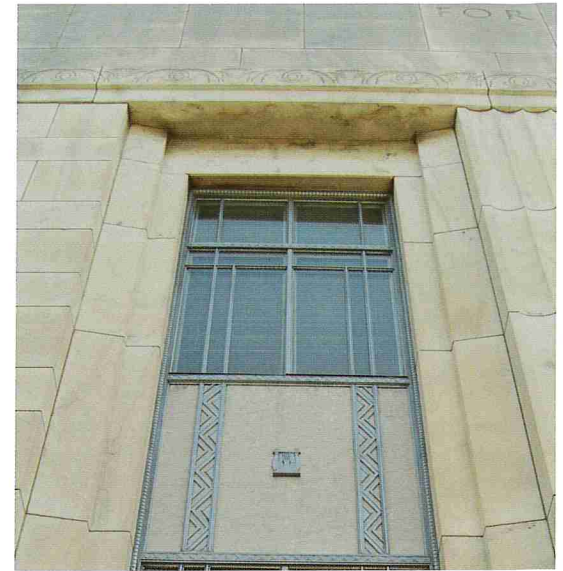
Figure 13. As early as the 1930s, companies primarily making aluminum windows often offered an option for an aluminum storm window, usually on the exterior. The left-hand photograph shows an early interior storm window piggybacked onto the primary window frame at the Folger Shakespeare Library (glass pane on the left). The photograph of the same window, from the outside, shows no indication of an interior storm.
